CMD 19-M4
File/Dossier # 6.02.04
e-Doc 5787337 PDF

Status Report on Power Reactors

Commission Meeting
February 20, 2019

Subject Update on the CNSC requests issued pursuant to subsection 12(2) of the *General Nuclear Safety and Control Regulations* related to internal contamination events in the Retube Waste Processing Building and in the Darlington Unit 2 Vault

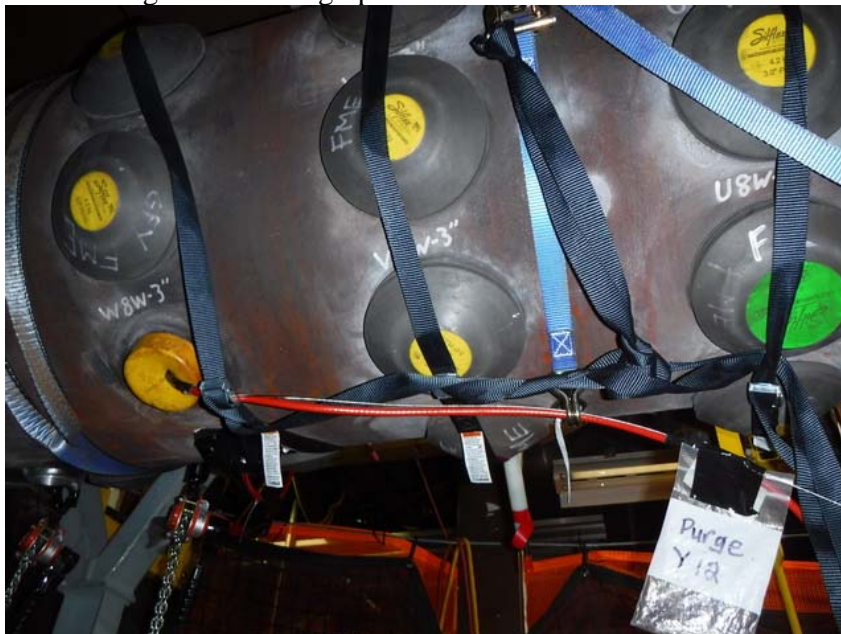
Nozzle Purge Dam Photograph

On February 7, 2019, OPG submitted the detailed event report summarizing the results of its investigation into the November 2018 occurrence. OPG's investigation identified that the cause of the event was "the failure to recognize the potential for localized airborne hazards during tool retrieval from the header nozzles during the Feeder Installation Series".

The Upper Feeder Installation Series involved the welding of new feeder tubes into the header nozzles. Part of the installation required the use of header nozzle purge dams (shown in the illustration below) to serve as Foreign Material Exclusion (FME) barriers and provide protection to the header internal surfaces during the welding operation.

It was later found that in some cases the header nozzle purge dams could not be readily removed following the welding operation. The nozzle purge dam components were removed using a wire and grabber tool that was pulled through the contaminated header.
