Update on Suncor Energy Inc. MacKay River fire incident

Action item from December 11-12, 2019 Commission Meeting (#20866)

Subject
Objet
Update on Suncor Mackay River fire incident and device removal

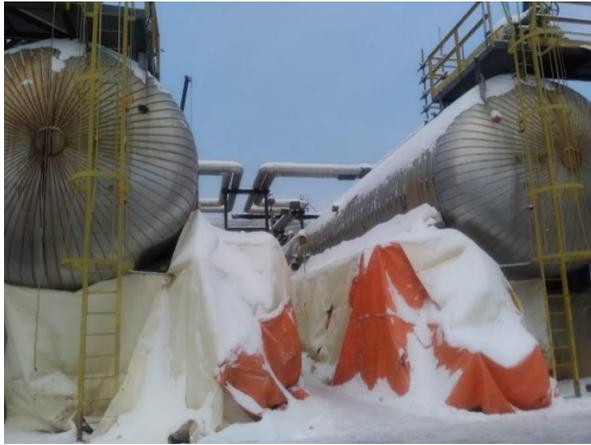
On December 21st a third party radiation safety consultant (Stuart Hunt & Associates Ltd.), who holds a CNSC licence allowing servicing of fixed gauges, arrived on-site at the Mackay River site to assess and evaluate the damage to the gauges affected by the fire. The four insertion gauges damaged by the fire were mounted on the high temperature separator vessels shown in Pictures 1 and 2. The assessment concluded that the fire had compromised the gauges, as there was clear evidence that some of the lead shielding had melted and escaped the sealed source housing.

Picture 1: High temperature separator vessels fitted with insertion gauges

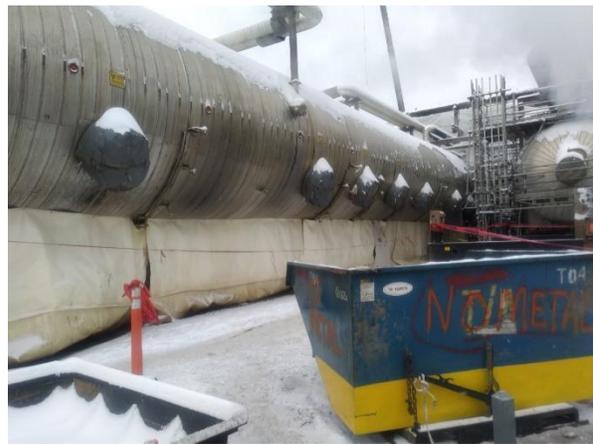
Picture 2: High temperature separator vessels fitted with insertion gauges

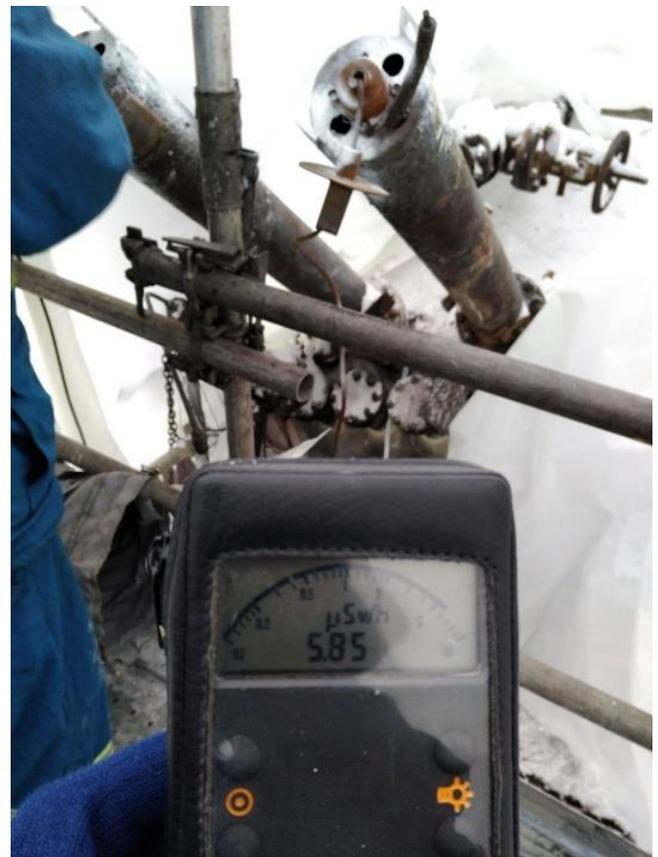
The technician measured a maximum radiation level of $60 \mu\text{Sv/hr}$ at approximately 60 to 100 centimeters away from the gauges, as seen in picture 3. These measurements were taken from the scaffolding installed to gain access to the gauges. There was no access to the gauges apart from the scaffolding and the entire area was cordoned off to prevent access

Picture 3: Dose rate measurement near the gauges

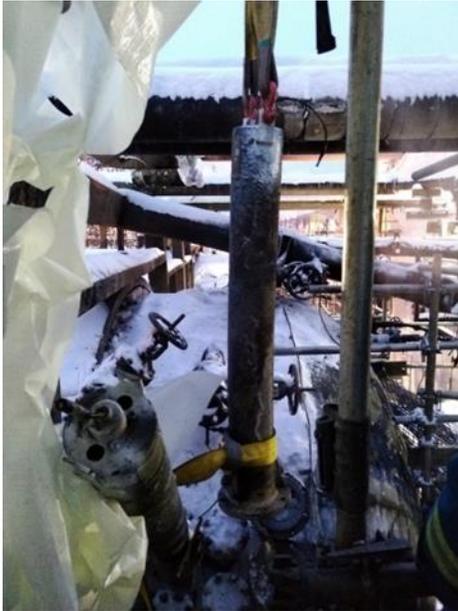
Picture 4: Source holder being prepared for lifting and removal

Two technicians from Stuart Hunt & Associates arrived on-site on January 16th, 2020 to perform the safe removal of the gauges. A CNSC inspector, Lindsay Pozihun, was also on site to observe the removal. Once the Stuart Hunt technicians completed the setup according to the approved plan, they began the detailed assessment of the gauges. The technicians observed that the source cables were stuck in lead that had melted and escaped from the source holder and were therefore not free to move from the drywell. Based on this observation, the technicians determined that the removal scenario to be used was removal of the four empty source holders followed by removal of the drywells that contained the sealed sources from the vessel. Those would then be packaged into Type A packages that would need to be specially manufactured. Pictures 4 and 5 show the removal of the empty source holders from the drywells.

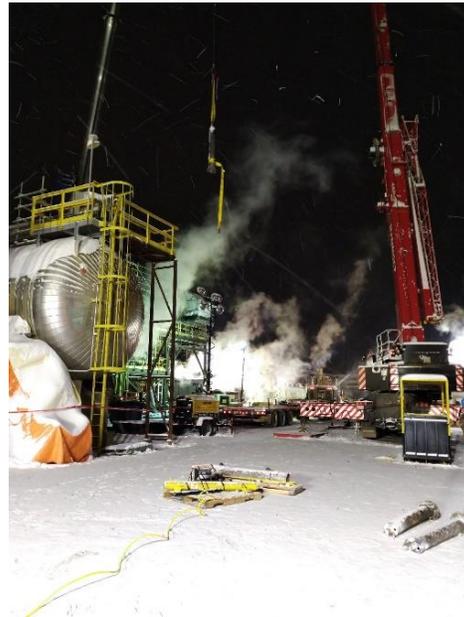
Picture 5: Source holder being lifted by a crane

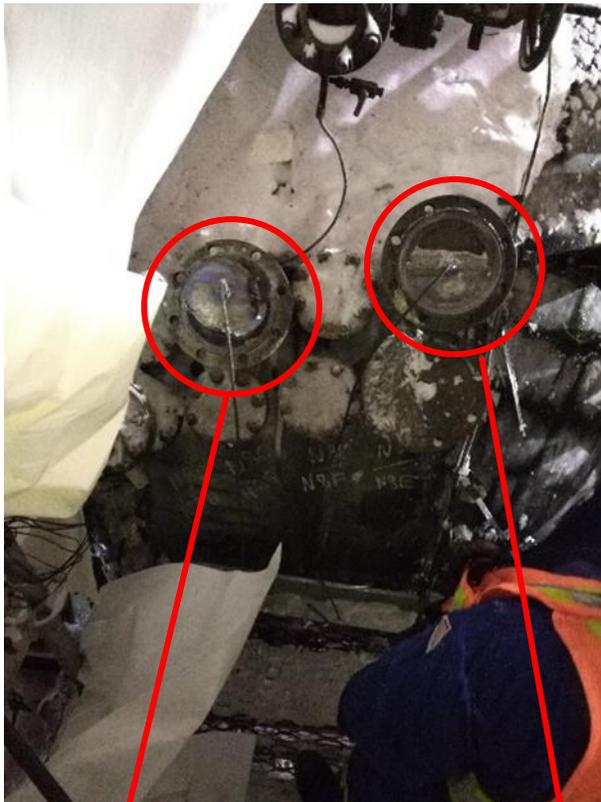
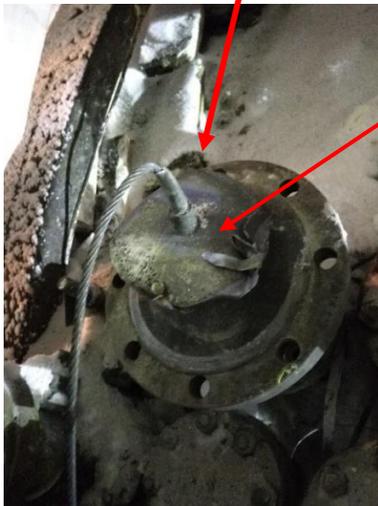
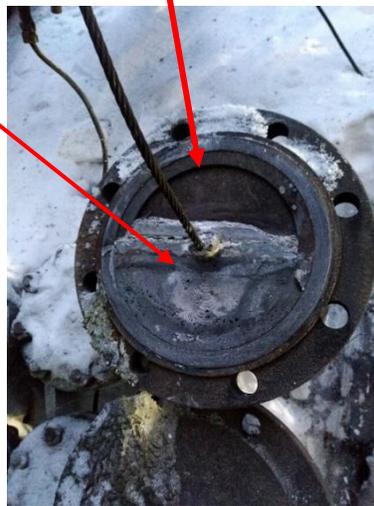
The extent of the lead that melted and escaped the source holder was clearly visible inside the source well, as shown in picture 6, and confirmed the assumption from the technician that the sources were stuck inside the well. Stuart Hunt's technicians were able to remove all four empty source holders from their mounted position by the end of day on January 16th, 2020.

Picture 6: Inner view of the drywell following removal of the source holders showing presence of lead

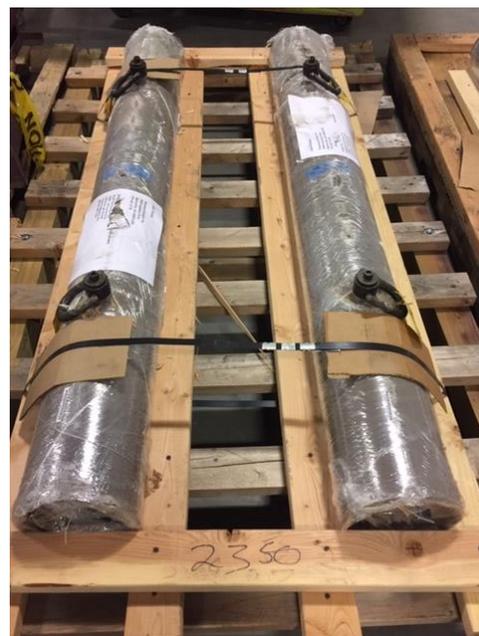
Picture 7 : Type A packages for the transport of the drywells (photo provided by Stuart Hunt and Associates Ltd.)

Stuart Hunt & Associates Ltd. submitted a plan for the preparation of the packages and safe disposal to the CNSC for review and approval. The plan consisted of cutting a portion of the length of the drywells to allow them to be inserted in a Type A package designed for the transport of source rods. Each of these packages was manufactured specifically for this purpose since the total length of the packages had to be sufficient for the portion of the drywell containing the sources. The packages were delivered to Stuart Hunt & Associates Ltd. on July 6, 2020. Picture 7 shows the Type A packages manufactured for the recovery of the sources.

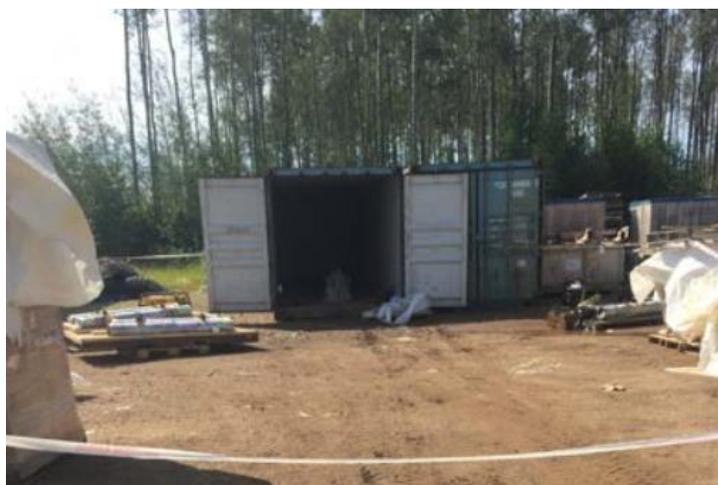
Picture 8 : Freight container used for the storage of the drywells provided by Stuart Hunt & Associates Ltd.

On July 30 2020, Stuart Hunt & Associates resumed work at the Suncor site and provided a report on the work performed on site to the CNSC on August 21. CNSC staff were not present for this portion of the work due to COVID travel restrictions. Picture 8 shows the freight container used to store the four drywells containing the sources. Picture 9 shows the four drywells inside the container.

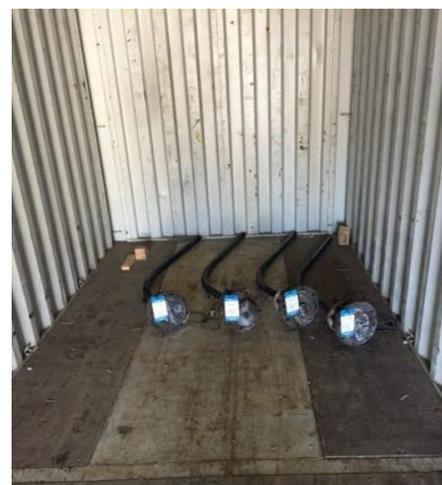
Picture 9 : Drywell inside the container provided by Stuart Hunt & Associates

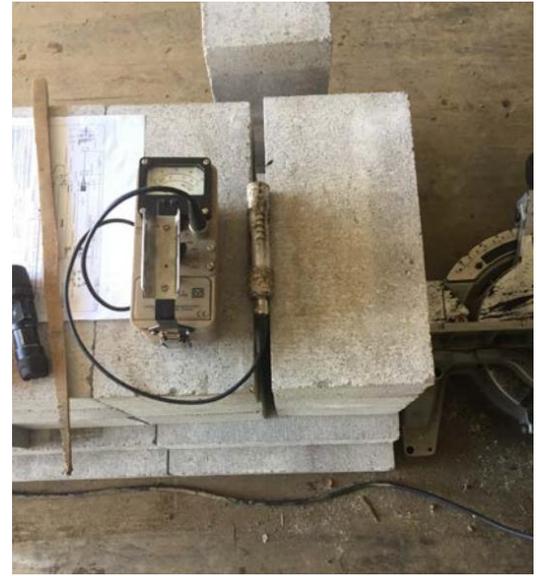
In the report submitted to the CNSC, Stuart Hunt and Associates Ltd. noted that the initial indication that all sources were in the straight position of the drywell was not confirmed when the drywells were inserted into the packages, and that at least one had sources located in the curved portion.

Picture 10 : Setup to measure dose rate provided by Stuart Hunt & Associates Ltd.

The technicians created a setup, shown in picture 10, allowing them to approach, locate and cut the drywell while being shielded for the sources using the concrete blocks shipped to the site for this purpose. The setup allowed them to accurately determine the position of the sources. For the cutting operation, it was not possible to shield the sources due to the location of the saw and the shape of the drywell as seen on picture 11. The maximum dose rate measured at the torso of the worker performing the cutting operation was 600 $\mu\text{Sv/h}$ and varied for each drywell due to the amount of lead that melted down into the drywell due to the fire. The total recorded dose for the two technicians who performed the recovery were reported as 199 μSv and 175 μSv , respectively.

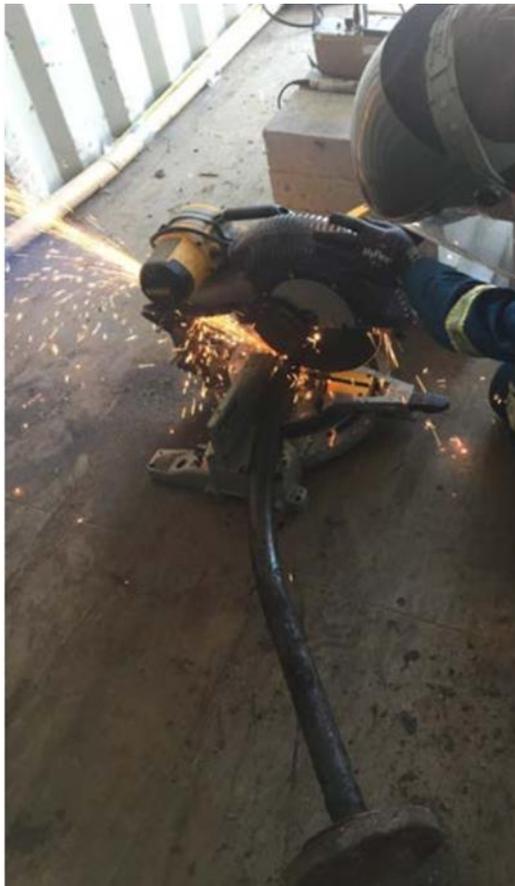
Picture 11 : cutting of a drywell provided by Stuart Hunt and Associates Ltd.

The preparation of the packages involved a cutting operation for loading the drywells into the Type A packages. From the assessment and radiation survey performed in January, it was believed that the five sources of each drywell were located in the straight portion of the well. Their plan was to slide the drywell into the package and confirm that all sources are inside the package and shielded. The curved portion of the drywell would then be cut to allow the drywell to fit into the package.
