## Event Initial Report

### **Orano Canada Inc., McClean Lake Operation**

Elevated Hydrogen Level in Leach  
Tank

| <b>EIR: Elevated Hydrogen Level in Leach Tank - Niveau d'hydrogène élevé dans le réservoir de lixiviation</b> | |

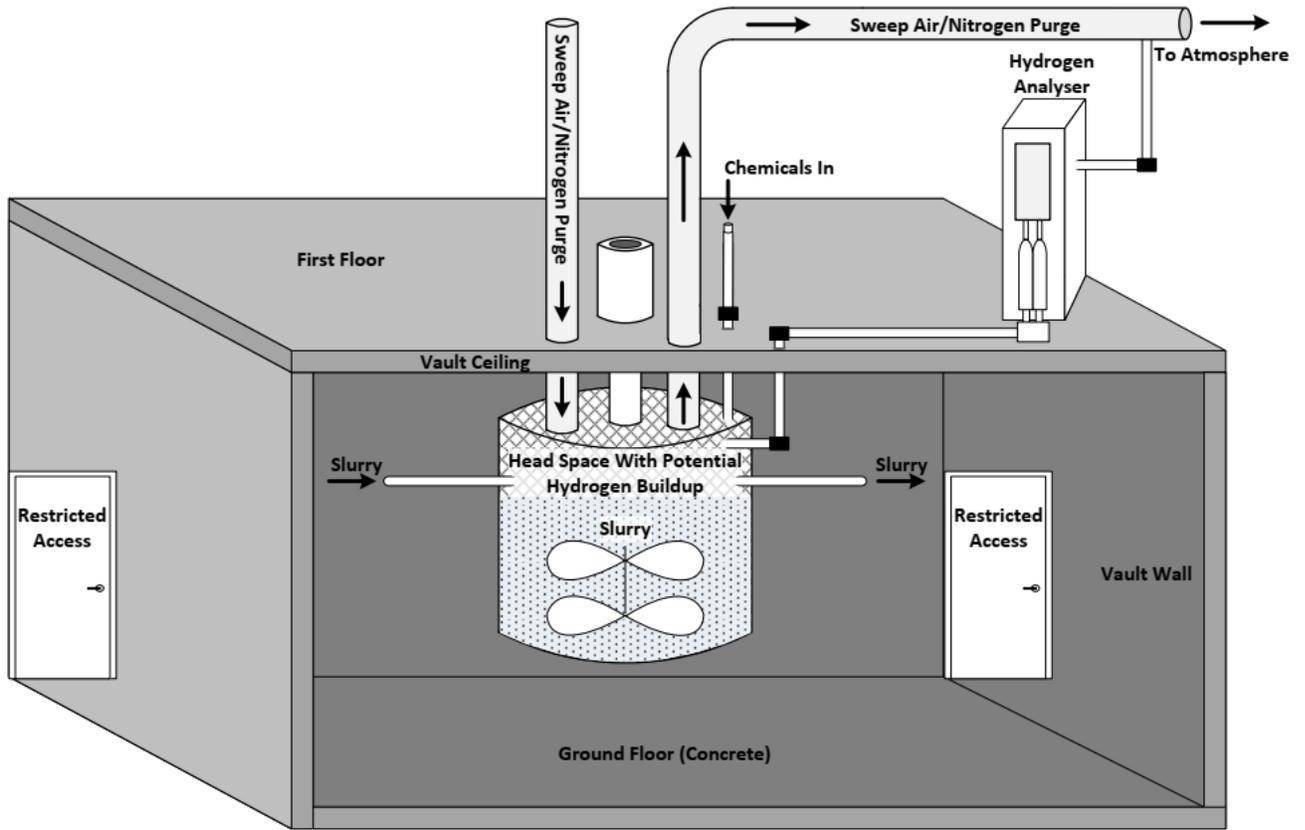
**Figure 1:** 3D view of Leaching Circuit  
(Source: Orano)

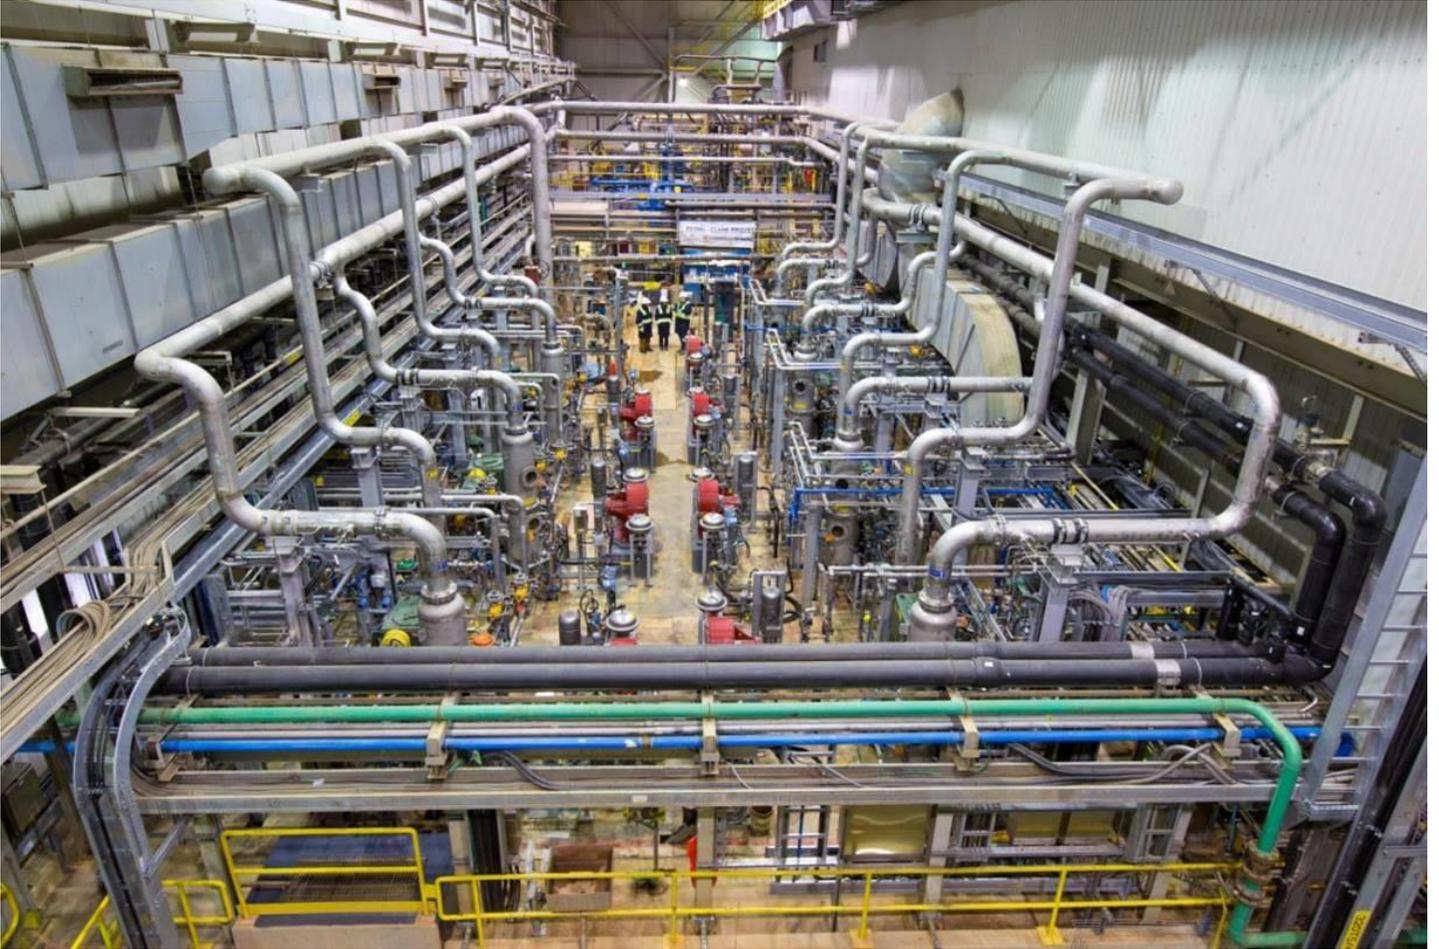
At approximately 07:30 on the morning of December 15, 2020, members of the incoming shift observed in the control room that the hydrogen levels in SLT #7 were elevated, but had not exceeded alarm threshold levels. The sweep air system for SLT #7 was returned to service and the resulting movement of sweep air into the tank caused a hydrogen analyser to register a level of 4.25%. Since this was well above the second alarm threshold of 2.4%, the system automatically activated the nitrogen purge system to place the tank into a safe state, as per design.

**Figure 2:** Sweep air system  
(Source: Orano)

- The tank was returned to a safe state by reactivating the sweep air system and the nitrogen purge system.
- The sweep air control valves to physically bypass the sweep air system were locked open on all seven secondary leach tanks. The locks can now only be removed by a Mill Operations General Supervisor.

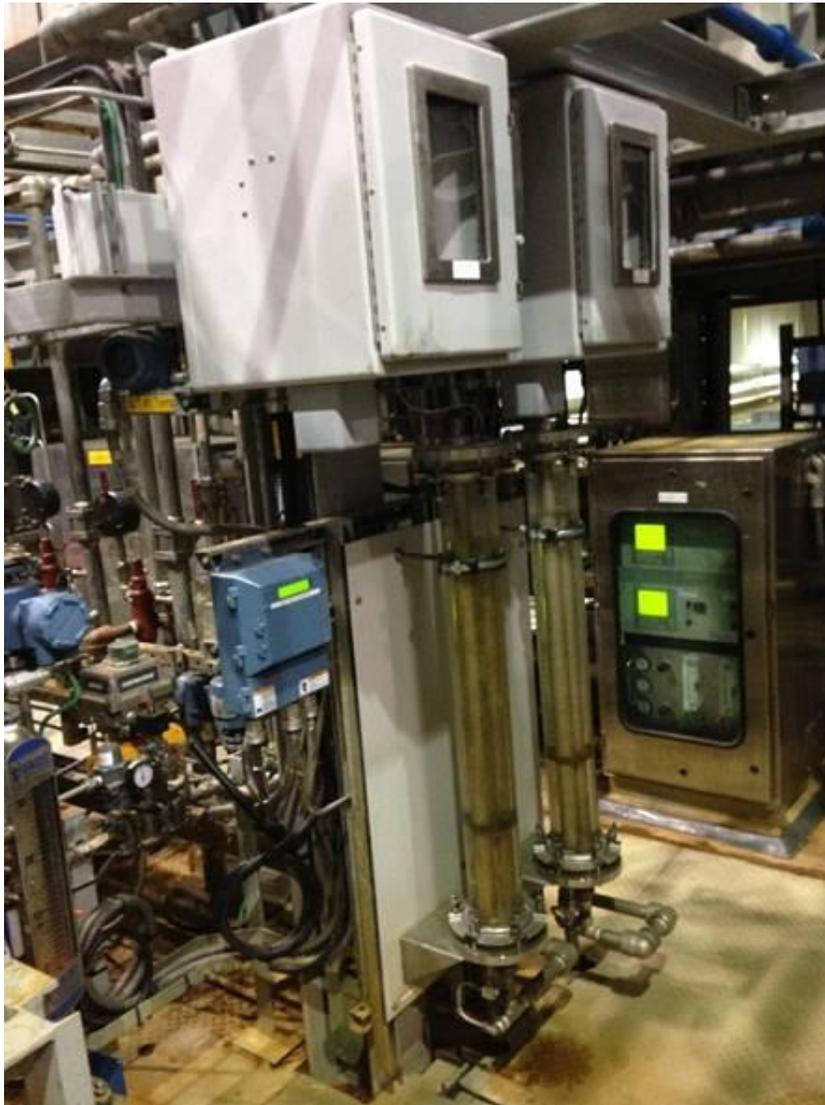
It should be noted that at no time was any hydrogen analyser in this circuit inoperable; the safety systems worked as designed, triggering the nitrogen purge system and the alarm as measured levels exceeded the 2.4% upper threshold.

**Figure 3:** Hydrogen gas analyser  
(Source: Orano)

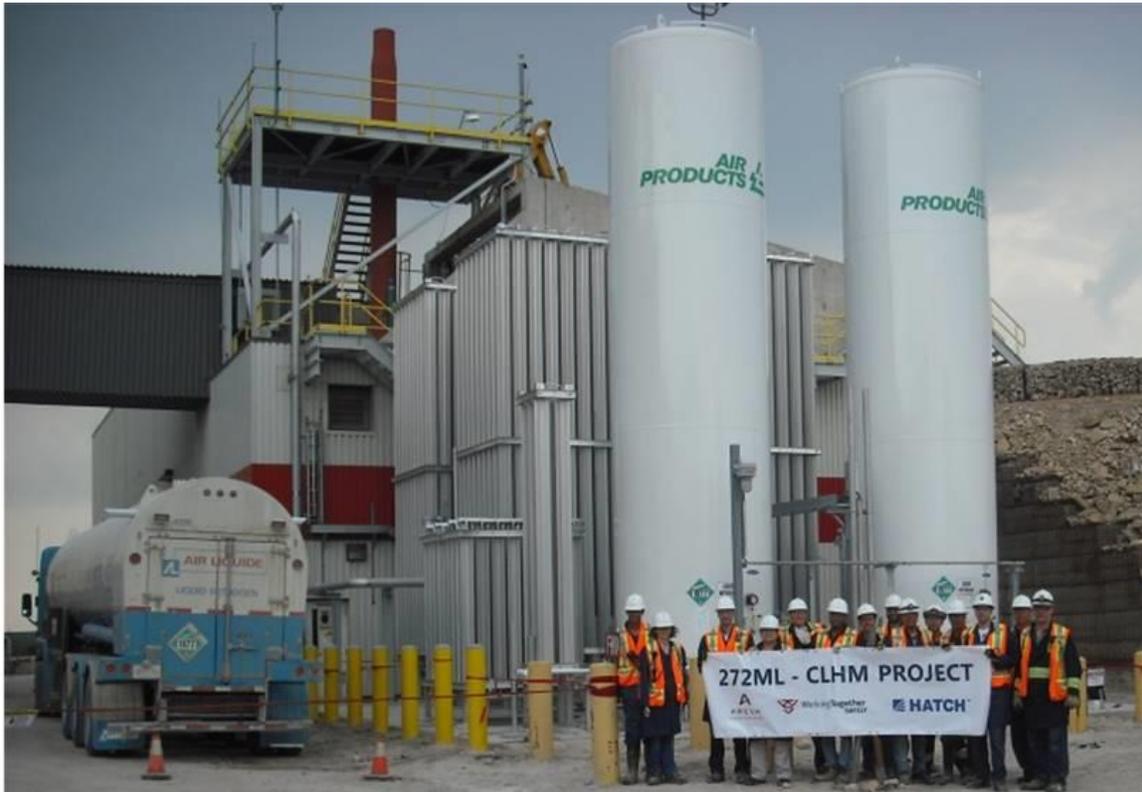
**Figure 4:** Nitrogen tanks  
(Source: Orano)
