**Update from CNSC Staff on  
exceedance of the annual dose limit  
for a Nuclear Energy Worker at  
Jubilant DraxImage**

Commission Meeting

**October 5, 2021**

Update on Event at Jubilant DraxImage Inc. involving high radiation dose to the thyroid of a Nuclear Energy Worker

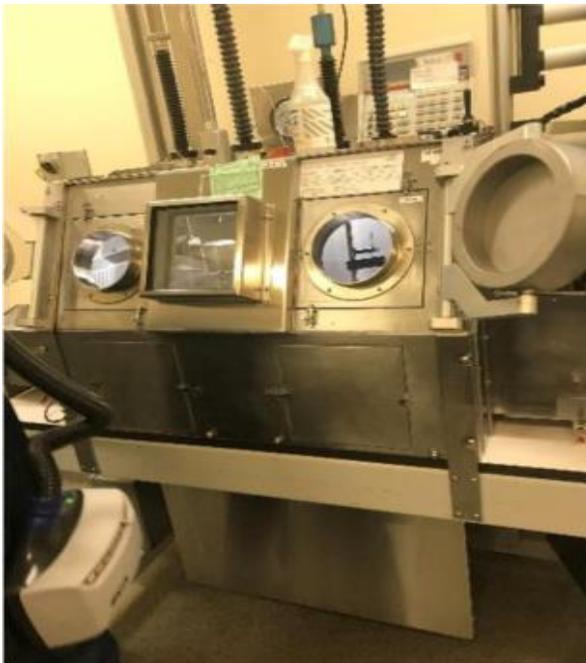
Figure 2: Shielded box Where the Spill Occurred

The RSO informed the duty officer that a lead pot containing a vial of iodine-131 (I-131) was brought into a ventilated radiation shielded box (Figure 2) on April 19, 2021. A hook was used to remove the lid from the lead pot and the lid of the lead pot fell from the hook directly onto the vial containing I-131, breaking the vial and causing a spill inside the shielded box (Figure 3).

An investigation conducted by the licensee identified that the spill could have been avoided if the lid of the lead pot had not fallen. This happened because the hook used to hold it was not secure. The hook used to hold the lid of the lead pot has been changed to a double hook system to ensure that the lid can be securely held at all times without the risk of falling.

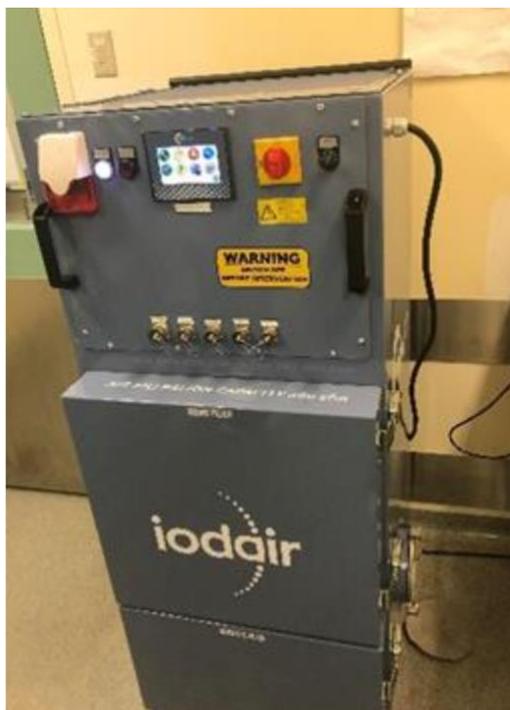
Figure 4: Portable Iodine Filtration Unit

The licensee brought a portable iodine filtration unit (Figure 4) into the room to reduce the airborne concentration of I-131. Approximately two hours later the I-131 concentration had reduced to 16% of the original concentration. The RSO and his assistant returned, wearing respirators, to clean up the interior of the shielded box, which they completed within 15 minutes.
