Update from CNSC Staff

**Update from CNSC Staff on
exceedance of the annual dose limit
for a Nuclear Energy Worker at
Jubilant DraxImage**

Commission Meeting

Subject / Objet Additional update on Event at Jubilant DraxImage Inc. involving high radiation dose to the thyroid of a Nuclear Energy Worker

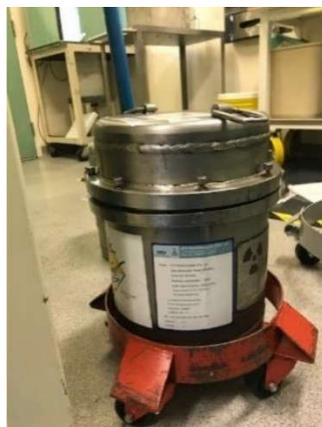
Figure 1: Certified Package

The raw I-131 material is received at DraxImage in a package that is certified by the CNSC and presented in Figure 1, due to the high activity of the material. As part of the certification process, the preparation for shipment procedure is reviewed by CNSC staff and each user must register the use of the package with the CNSC and confirm that they have the proper instructions for the use of the package. In this case, the I-131 is contained in a glass vial inserted into an inner container of the package that is designed to prevent any leakage in case of accidents during transport.

All packages containing nuclear substances are required to be designed and transported in accordance with the CNSC’s *Packaging and Transport of Nuclear Substances Regulations, 2015*. The design includes all aspects of packaging including the outer package where the identification labels are applied, the inner glass vial that contains the nuclear substance as well as the preparation of the package for transport. A certified package may only be shipped in the configuration of the design that it was certified for.
